Upper Stillwater River Assessment

Prepared by:
Warren Kellogg
Stream & Watershed Consulting
38 Hidden Valley Drive, Clancy, MT 59634
March 2014

Stillwater Valley Watershed Council
and
Stillwater Conservation District

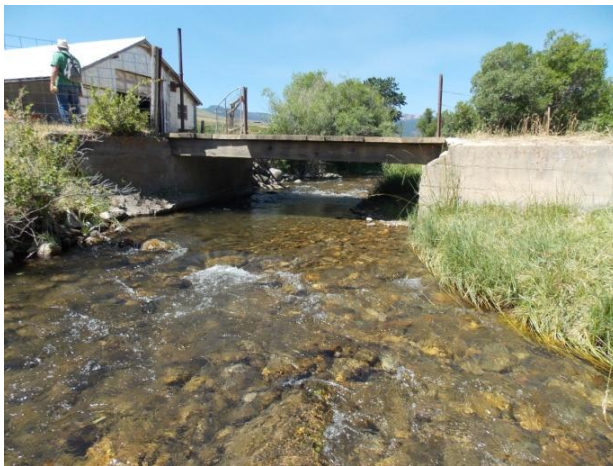
Private bridge crossing at the ranch buildings. The wood beam bridge has a 16 foot free span sitting on concrete abutments. The bridge is located on a bend. During high water, shear stress on the south abutment has caused minor scouring of the abutment footings. The north road approach restricts high flow access to the historic floodplain.

Bridge crossing at ranch buildings.

- 1) Repair the scoured footing on the south abutment.
- 2) When the bridge is ready to be replaced, consider moving it upstream about 100 feet to a straighter, more stable section of channel. Increase the bridge span to 20 feet giving it more capacity to pass high flows.

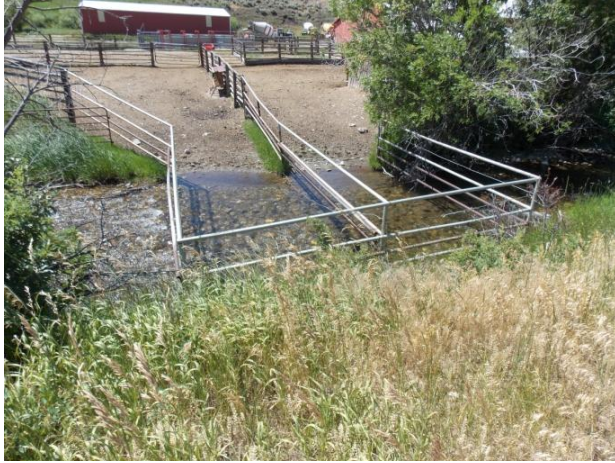
Small corral system with two water gaps on south side of creek. A 10 – 15 foot wide vegetative buffer separates the corrals and the stream. During snow melt and heavy rain run-off, elevated concentrations of nutrients from the manure pack may drain into the creek.

Small corral system located next to Limestone Creek.

Recommendation: The landowner worked with the local NRCS office to make changes to the corral system.

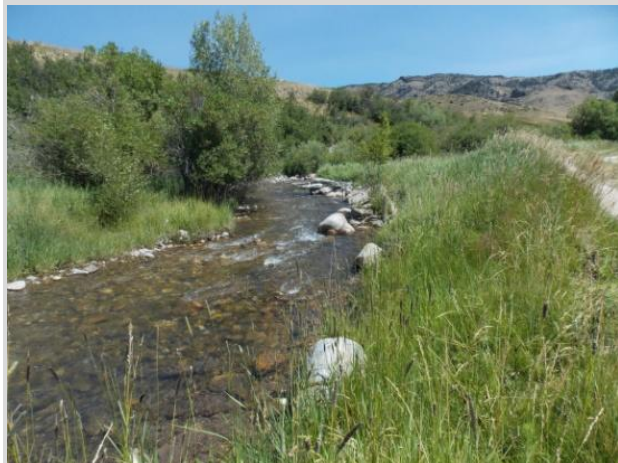
Looking downstream from Site LS-7, the stream runs east along the north fringe of the valley. A farm road parallels the creek channel.

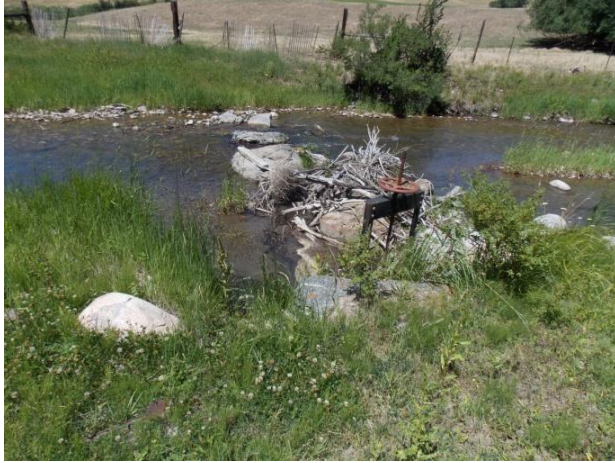
Small turnout structure and cross-channel rock diversion on the south bank. The turnout is a water control gate attached to a pipe that conveys water to an off-stream pond. There is no headwall. Floating debris tends to build up on the rocks next to the gate. The pond is partially silted in and no longer holds fish.

Cross-channel rock diversion with a small slide gate on the south bank that delivers water to an off-stream pond.

Recommendation: If the pond is used again, the diversion would be more effective if the rocks were replaced with portable concrete blocks. It would take three blocks to divert sufficient water into the headgate. The blocks would be placed in the channel during late summer low flows and removed before winter. The gate should be attached to a concrete or metal headwall.

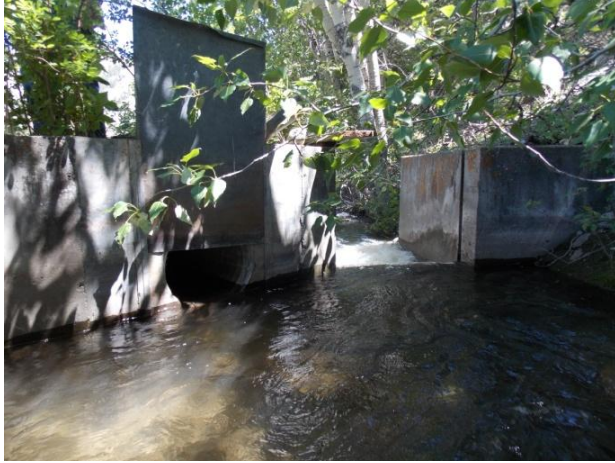
The concrete irrigation structure is located 400 feet down an open ditch above the south bank. It is a 3-way structure that returns irrigation water to the creek (board check), turns water out into an irrigation lateral (slide gate), or passes water down the main ditch (board check). The structure appears to be new and provides irrigation water to 3 – 4 acres of pasture on the south floodplain. The entrance to the open ditch does not have a gate to control the amount of water entering the ditch. High flows and floating debris may be a recurring problem for this structure.

Three-way concrete irrigation structure on the side of the creek.

Recommendation: Construct a water control structure at the entrance of the open ditch to prevent bedload and floating debris from clogging the headgate.

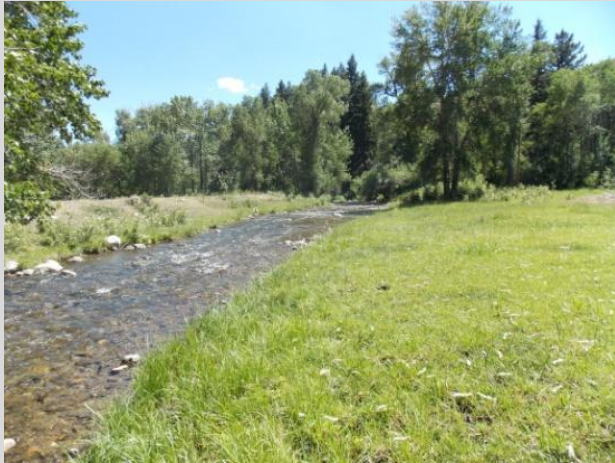
Limestone Creek downstream from Site LS-12. Riparian vegetation along the stream is intermittent.

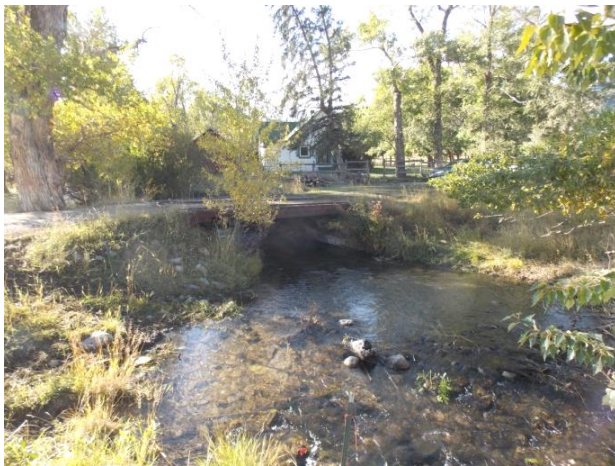
Private bridge access to ranch outbuildings and hay fields on the east side of the creek. The steel railcar bridge has an 18 foot free span resting on rock/concrete slab abutments. Minor scouring is occurring on the upstream side of the east abutment. There is 4 feet of freeboard between the bridge beams and the creek. The bridge approaches are not elevated and do not restrict out-of-bank flow. If the bridge plugs with debris, out-of-bank flows could affect a house (Site LR-4) about 120 feet away. There is a shallow swale on the west floodplain that may direct flows towards the house.

Bridge crossing provides access to ranch buildings and fields on the east side of the creek.

Recommendation: When the bridge is repaired or replaced, extend the span to accommodate high flows and lessen the possibility of the bridge plugging with debris.

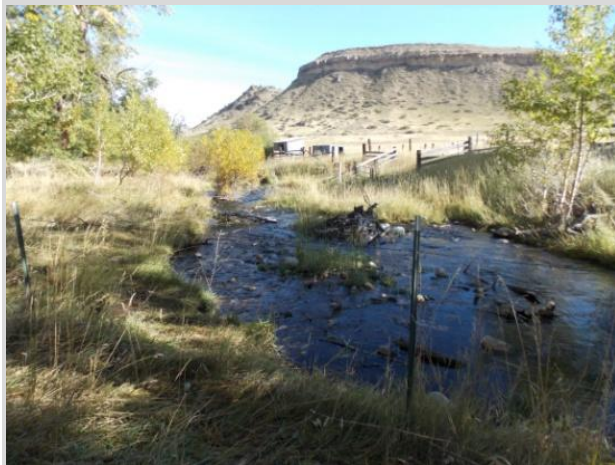
Old corral system downstream from Site LR-4. The stream channel is relatively wide and shallow from previous use. With the current management, the channel is beginning to stabilize.

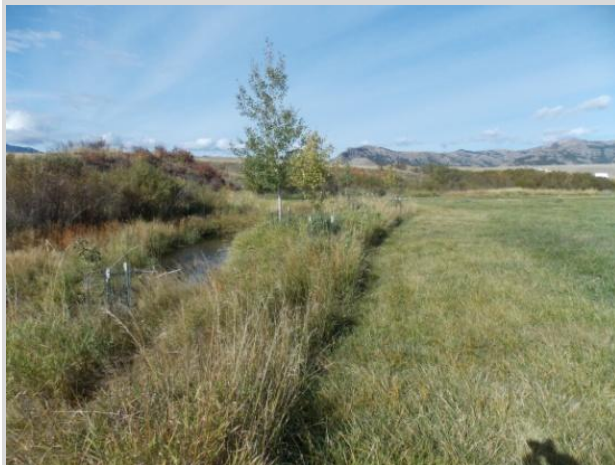
A narrow riparian buffer separates Little Rocky Creek from an adjacent hay field.

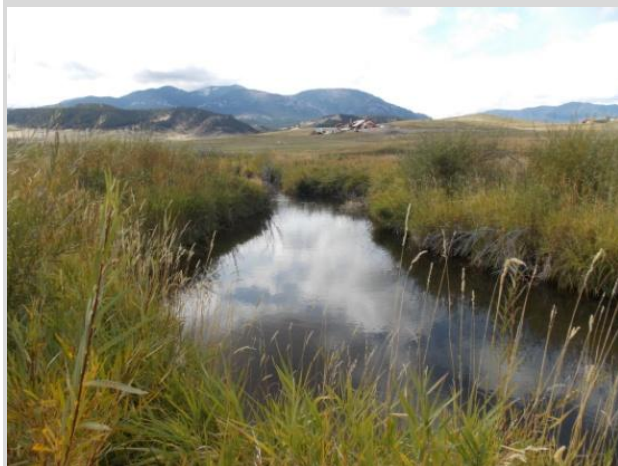
Beaver dam backwater ponding. Dense riparian vegetation along the creek is common.

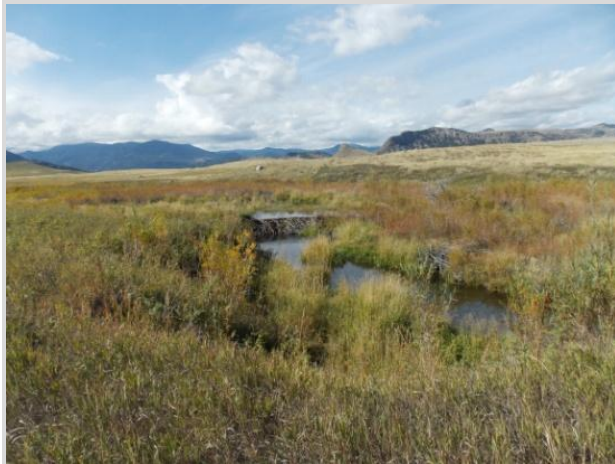
Large beaver dam on the upper end of Reach 5. The dam has elevated the channel grade and water table conducive to a healthy riparian corridor.

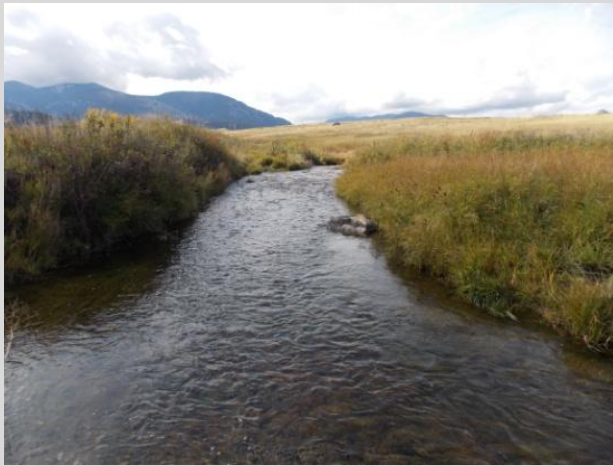
Channel Characteristics: The upper half of Reach 6 is a single-threaded channel with a gravel bottom. The creek is entrenched up to 6 feet into the floodplain. Beaver dams are found on the lower half of the reach; some up to 5 feet high. The beaver dams contribute to a flat channel gradient, long pools, and a high water table. There is minor bank erosion on some east side bends, but none are a significant problem.

The upper segment of Reach 6 is a higher gradient, single-thread creek channel with a gravel bottom.

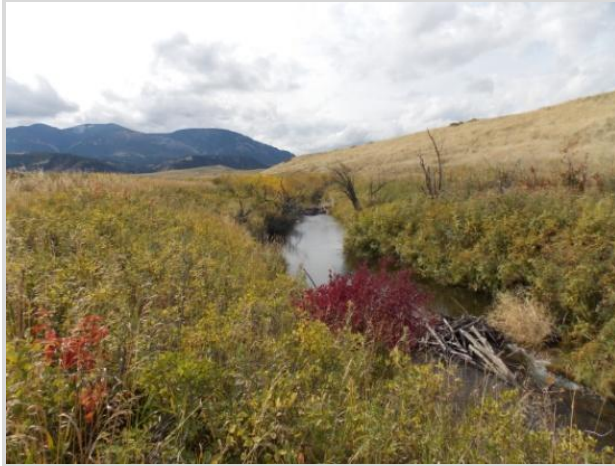
channel is entrenched 6 – 8 feet along most of this reach. Minor bank erosion was noted on a few outside bends along the hay field and farm road. Comparing current day conditions with 1951 aerial photography, little change has occurred over the last 60 years.

Beaver dam and backwater ponding help maintain a dense riparian plant community along the creek.

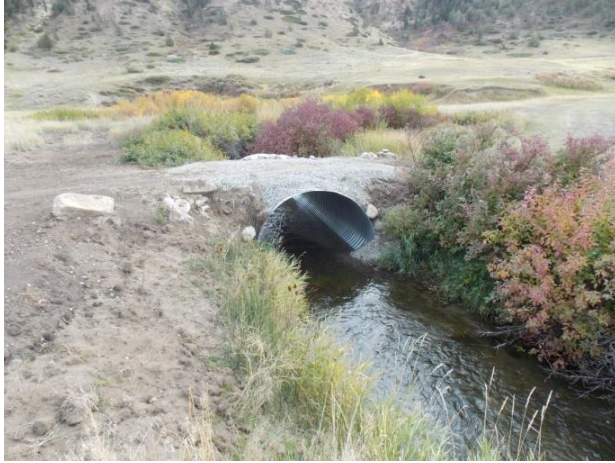
(Little Rocky Creek – Map #1)

Private culvert crossing (less than two years old) provides landowner access to land parcels on opposite sides of the creek. The crossing is a 6 foot diameter culvert, 15 feet long, that is covered with dirt and pea gravel. Cobble rip-rap has been placed on both the inlet and outlet.

Culvert crossing on lower Little Rocky Creek.

Recommendation: This crossing may cause a channel restriction that is vulnerable to flooding and/or floating debris. Nearly 40% of the channel capacity has been lost. Since the crossing is new, it is unlikely there would be interest in replacing it so soon. But, in the future, when it does need repairs or replacement, constructing a bridge in the same location with a minimum 12 foot span and upper bank abutments (concrete or timber) is suggested.

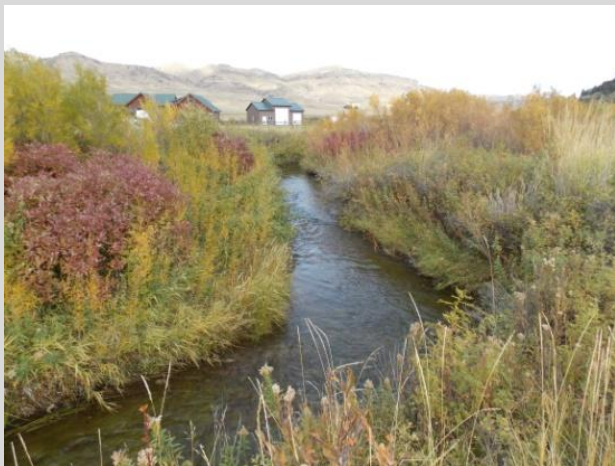
Channel Characteristics: The channel is entrenched 4 – 6 feet and is single threaded with a gravel bottom. It has a dense riparian fringe that makes it very stable.

Dense riparian vegetation along the creek channel.

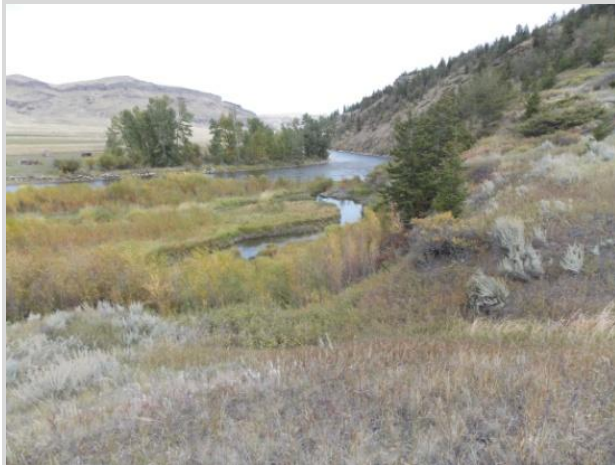
Reach Description: Reach 9 includes the corner of a large pasture that is not part of the Spreading Winge Subdivision. There is a livestock water gap on the upper end of the reach. A small, slow moving landslide along the east boundary of the creek is not causing a problem. Little Rocky Creek enters the Stillwater River at the end of Reach 9.

Little Rocky Creek confluence with the Stillwater River. The edge of the landslide is in the photo foreground.

Recommendations: Continue managing the creek and floodplain as they are now.
